## **FAILURE OF FUNDAMENTAL DUTY OF CARE.**

<b>OTECH</b>	INCIDENT REPORT - Ocean GreatWhite, Las Palmas Diver Decompression Sickness			Page 1																																																	
<div style="text-align: center;"> <p><b>INCIDENT REPORT</b>  <b>Ocean GreatWhite, Las Palmas</b>  <b>Diver Decompression Sickness</b>  <b>10.12.2018</b></p> </div>																																																					
<table border="1"> <thead> <tr> <th>Rev</th> <th>Date</th> <th colspan="2">Description</th> <th>Originator</th> <th>Checker</th> <th>Approver</th> </tr> </thead> <tbody> <tr> <td>A</td> <td>05.02.2019</td> <td colspan="2">Issued for Use</td> <td>MSL</td> <td>JKO</td> <td>OAT</td> </tr> <tr> <td>1</td> <td>01.02.2019</td> <td colspan="2">Issued for Internal Review</td> <td>MSL</td> <td>JKO</td> <td>OAT</td> </tr> <tr> <td>0</td> <td>21.01.2019</td> <td colspan="2">Draft</td> <td>MSL</td> <td></td> <td></td> </tr> </tbody> </table> <p style="text-align: center;"><b>Signature Legend</b></p> <table border="1"> <thead> <tr> <th>Originator</th> <th>Name</th> <th>Initials</th> <th>Position</th> <th>Signature</th> </tr> </thead> <tbody> <tr> <td>Originator</td> <td>Mikal Sjur Lothe</td> <

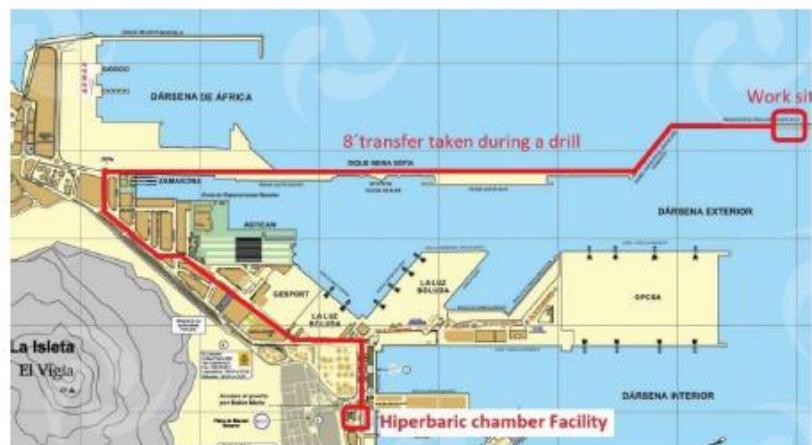
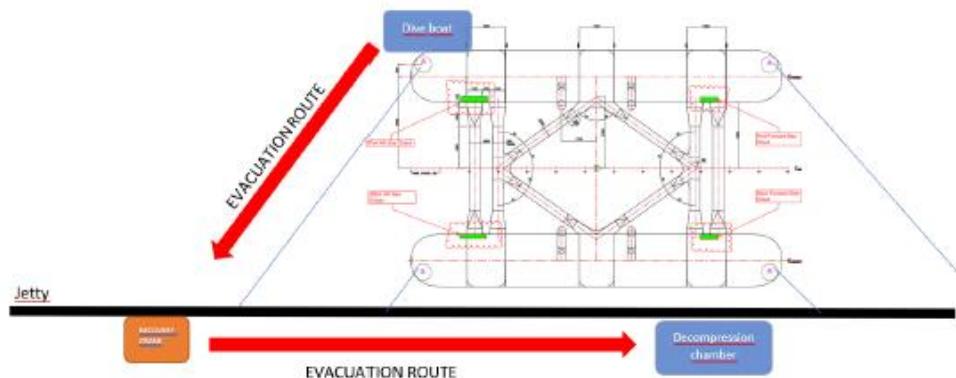
The below figures are the lay-out of the site the Hyperbaric Centre locations, and the evacuation route from the Dive site to the Otech DDC.
